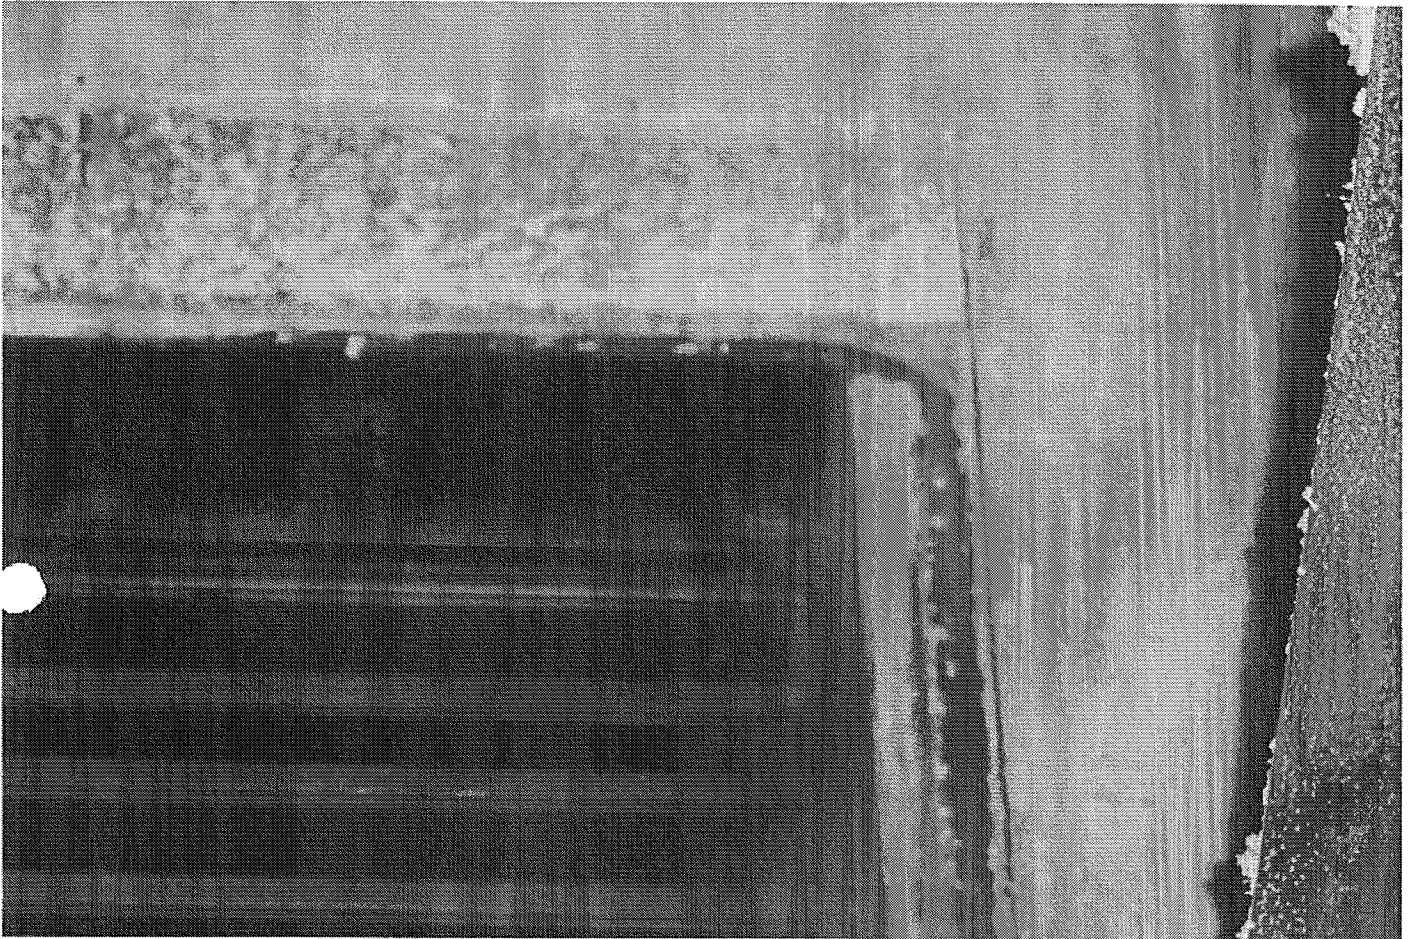
1. 20th floor, NE Fresh Air Shaft - View of fireproofing overspray above fire dampers

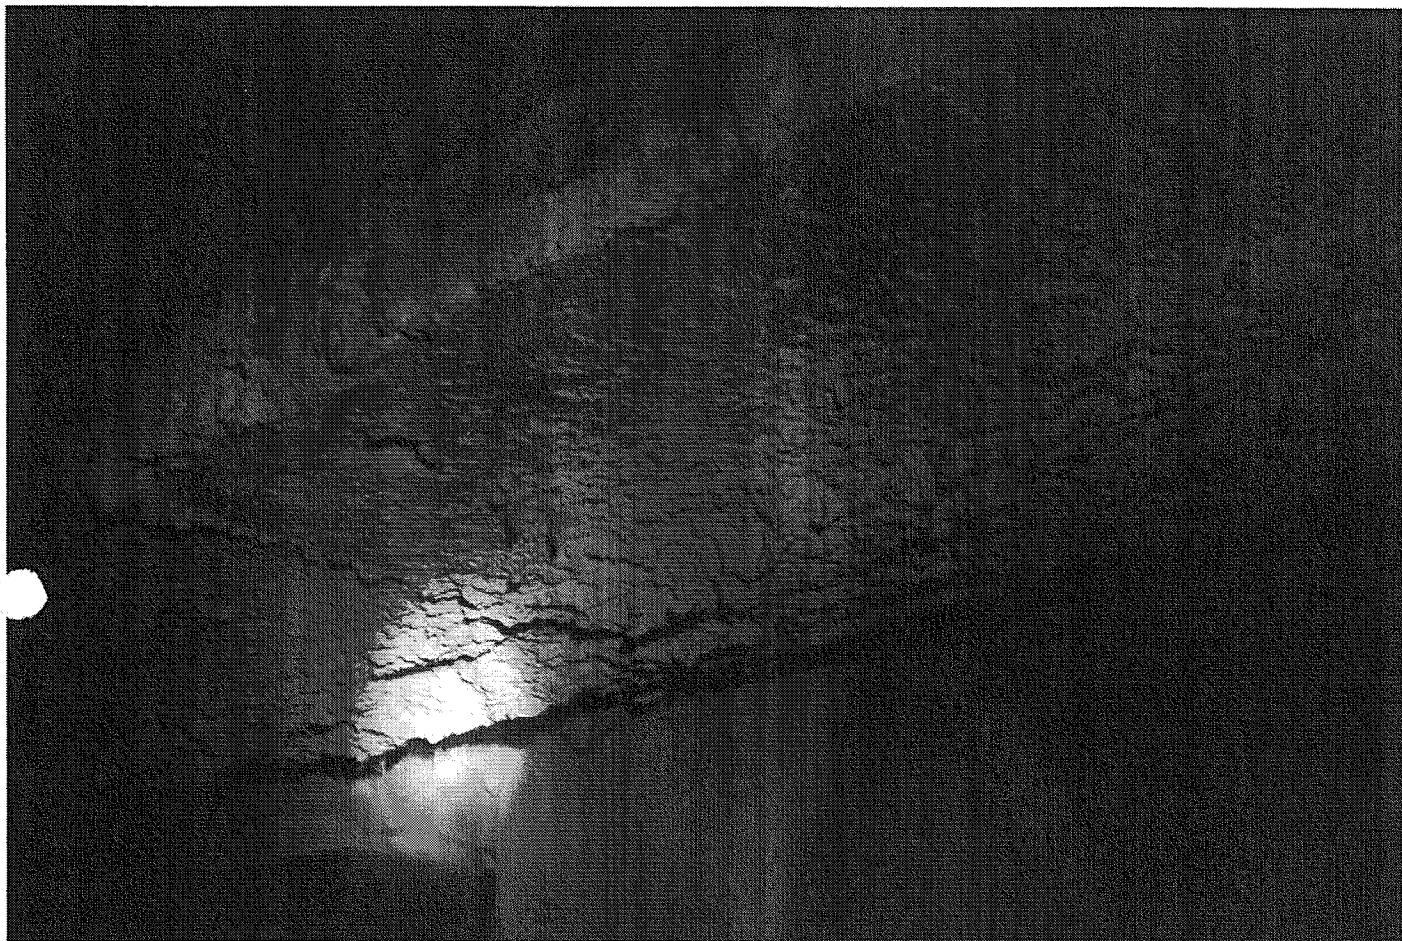
2. 20th floor, NE Fresh Air Shaft - View of fireproofing on concrete structure

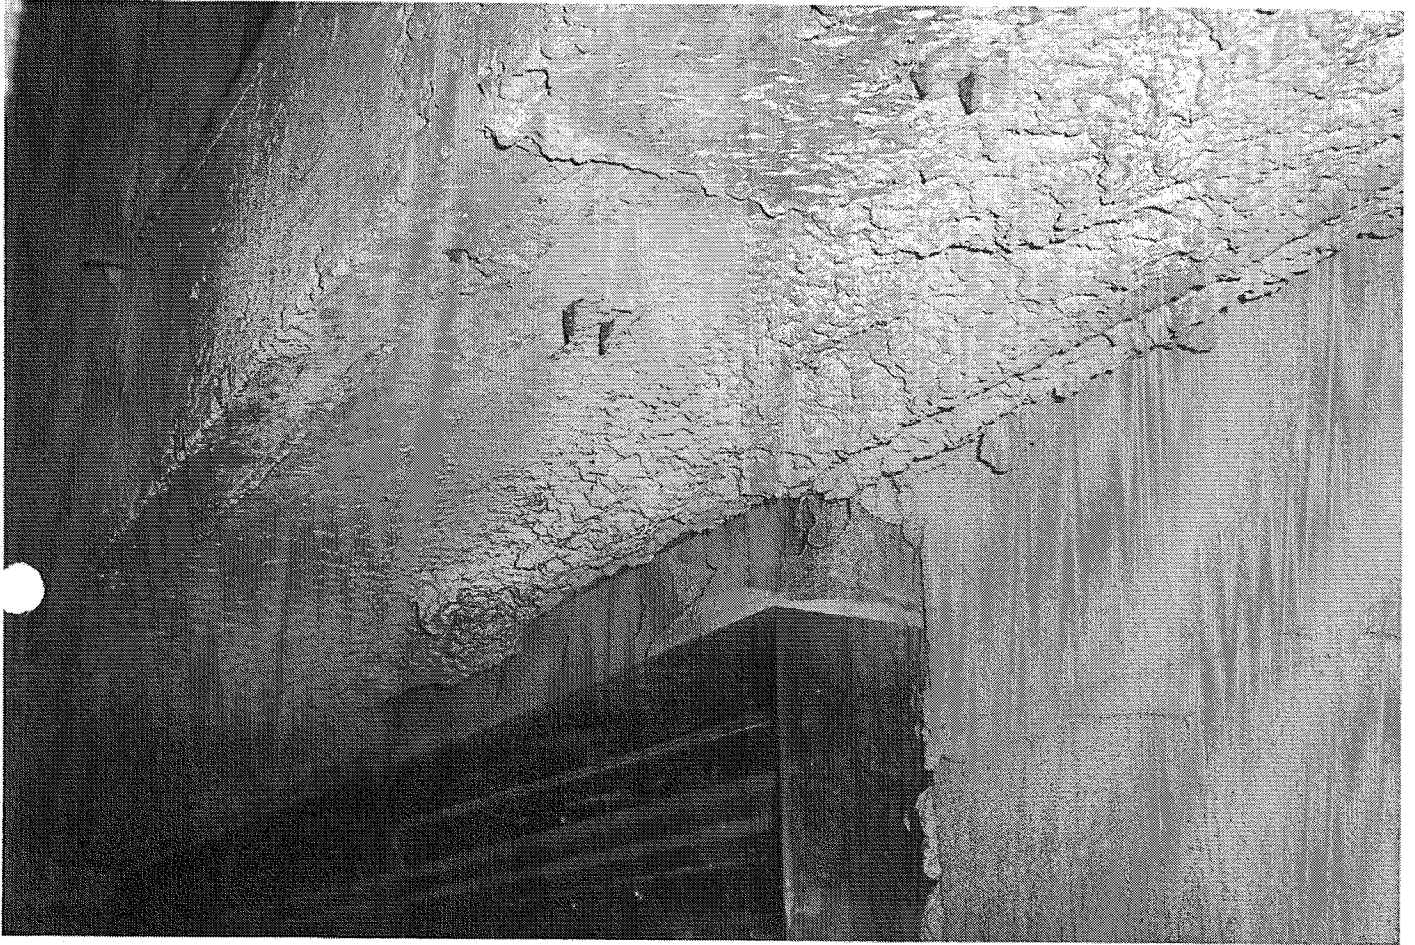
3. 20th floor, NE Fresh Air Shaft - View of damaged fireproofing on concrete structure (above dust sample location #1)

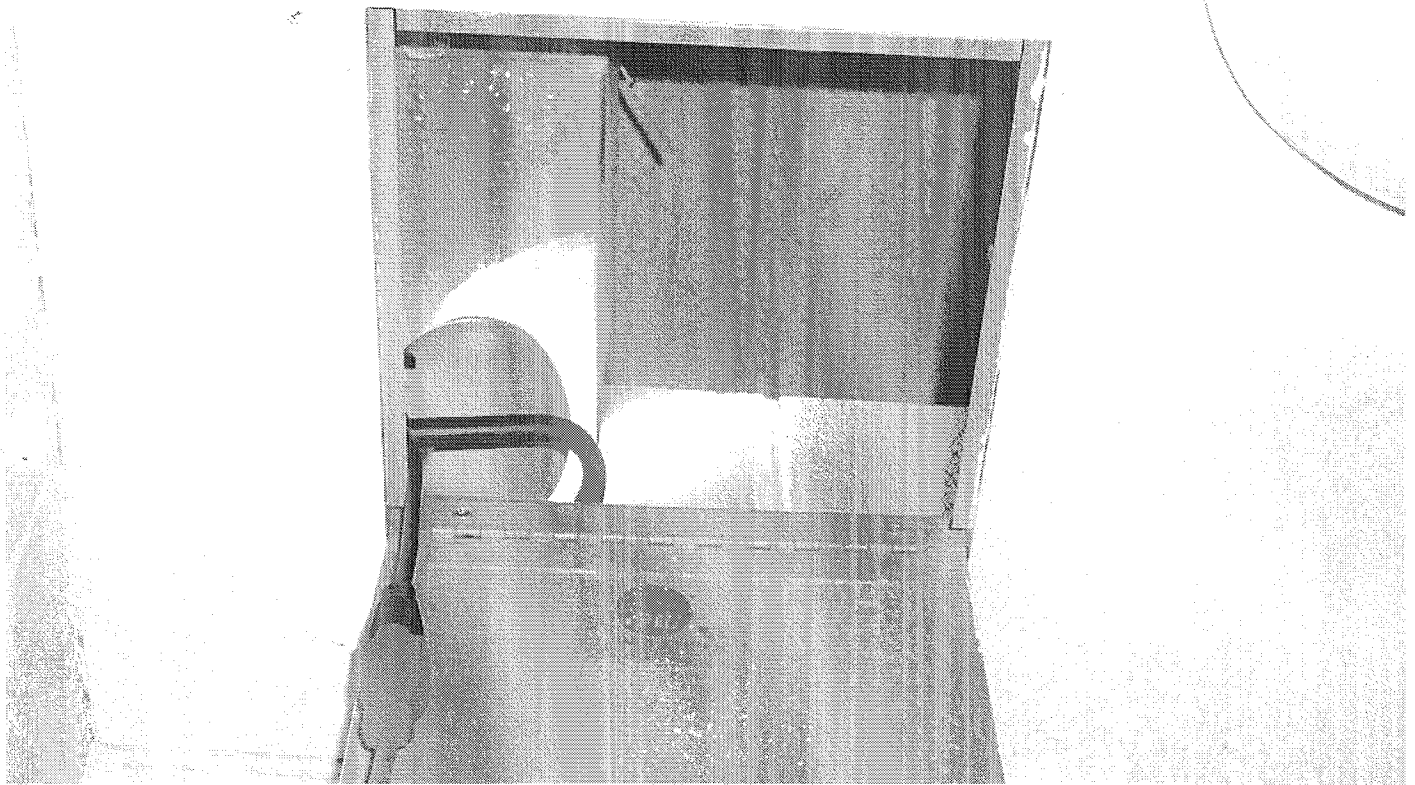
4. 10th floor, room 1003 - General view of fireproofed decking above plaster ceiling (thru access hatch)

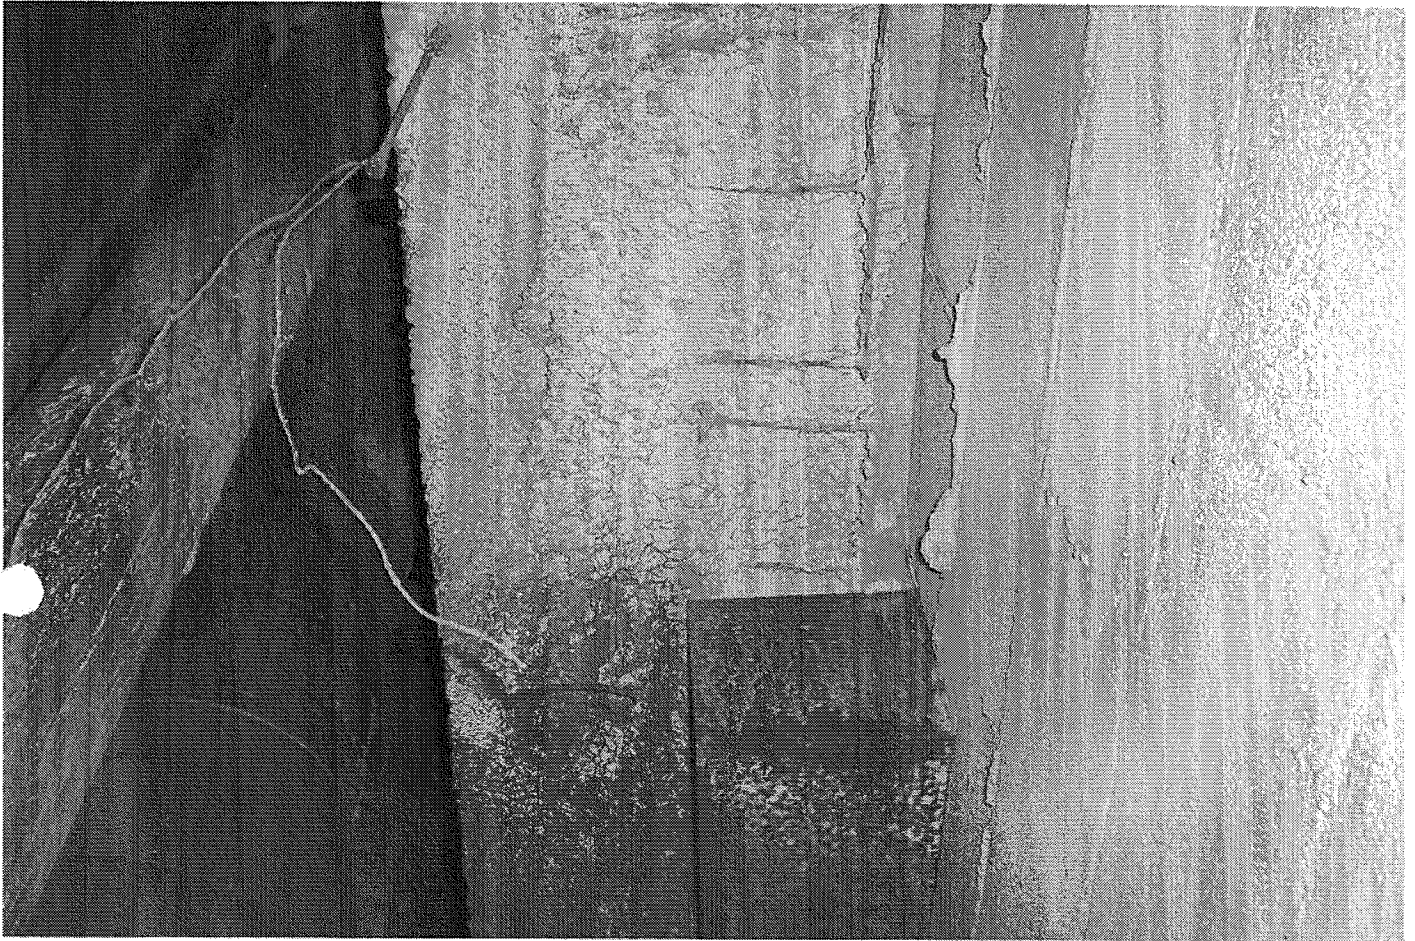
5. 5th floor, NE Fresh Air Shaft - View of fireproofing on concrete structure and black iron

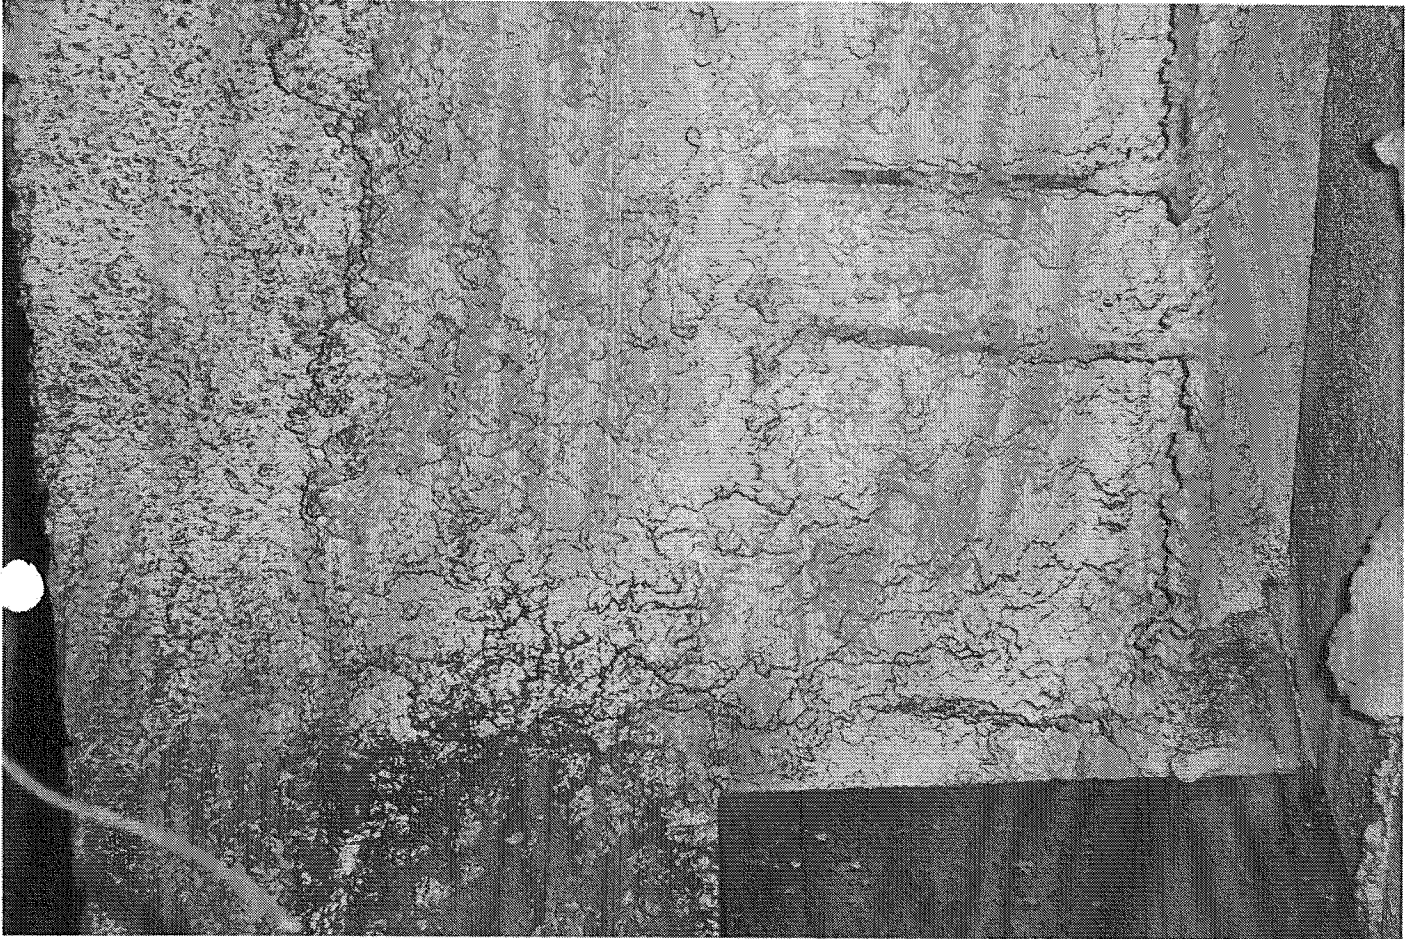
6. 5th floor, NE Fresh Air Shaft - Close-up view of fireproofing on concrete structure and black iron
